Inspection Report
Minerals Regulatory Program
April 24, 2006

Mine Name: Carr Fork/Pine Canyon
Operator Name: Kennecott Utah Copper
8315 West 3595 South
P.O. Box 6001
Magna, Utah 84044-6001

Permit number: M/045/004
Inspection Date: April 21, 2006
Time: 1:30 PM

Purpose of Inspection:
Annual inspection of this site.

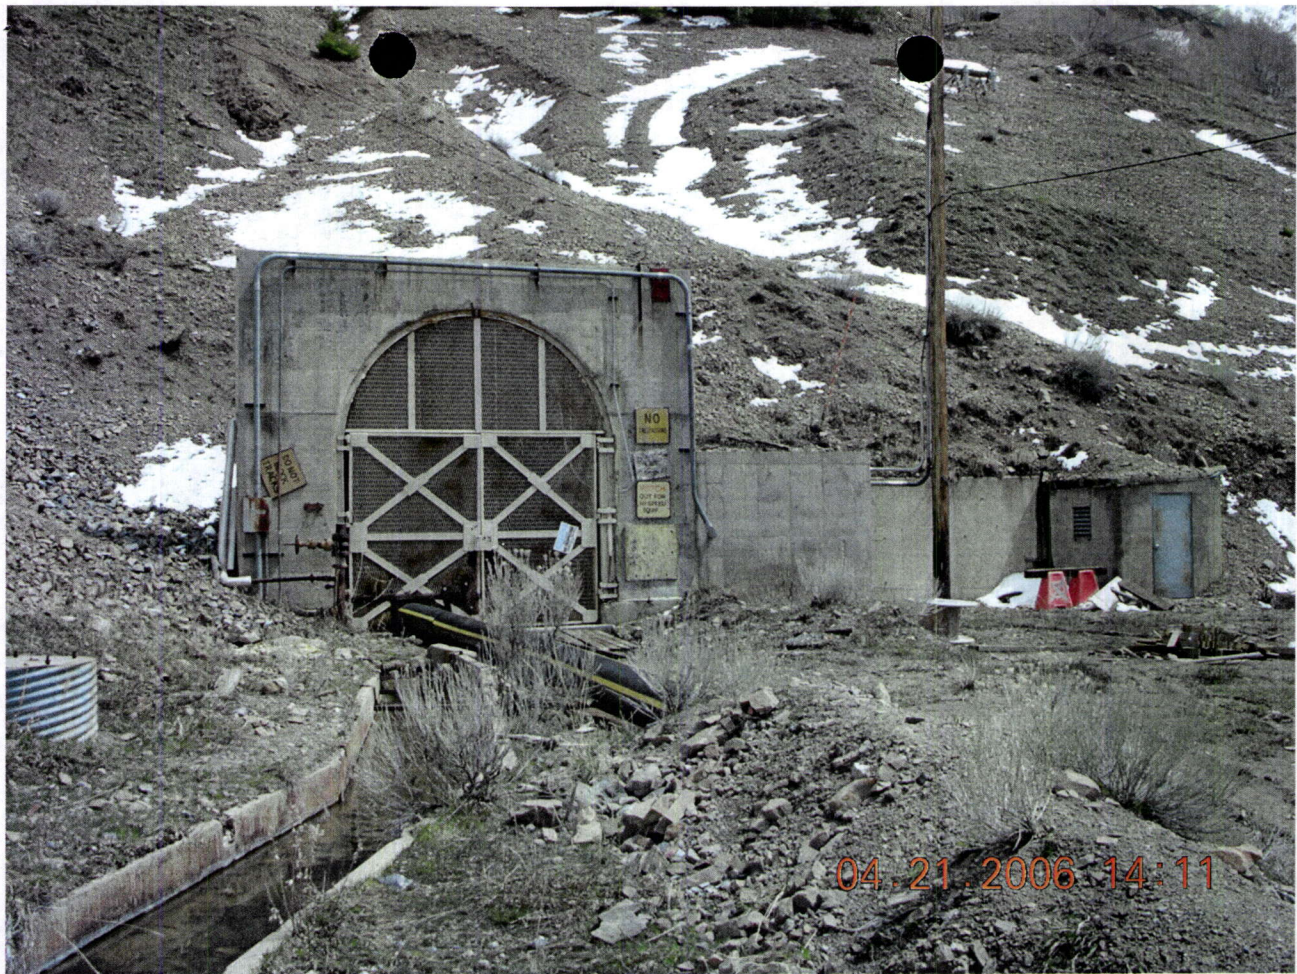
Carr Fork 004.jpg 2006/04/21 14:11:57

The Parvenu Portal presently has a steel frame and wire mesh closure that prevents unauthorized access and also allows for ventilation. The portal closure was in good repair at the time of this inspection. The area around the portal, headframe and service shaft were clean at the time of my inspection with no environmental concerns.

PARVENU PORTAL

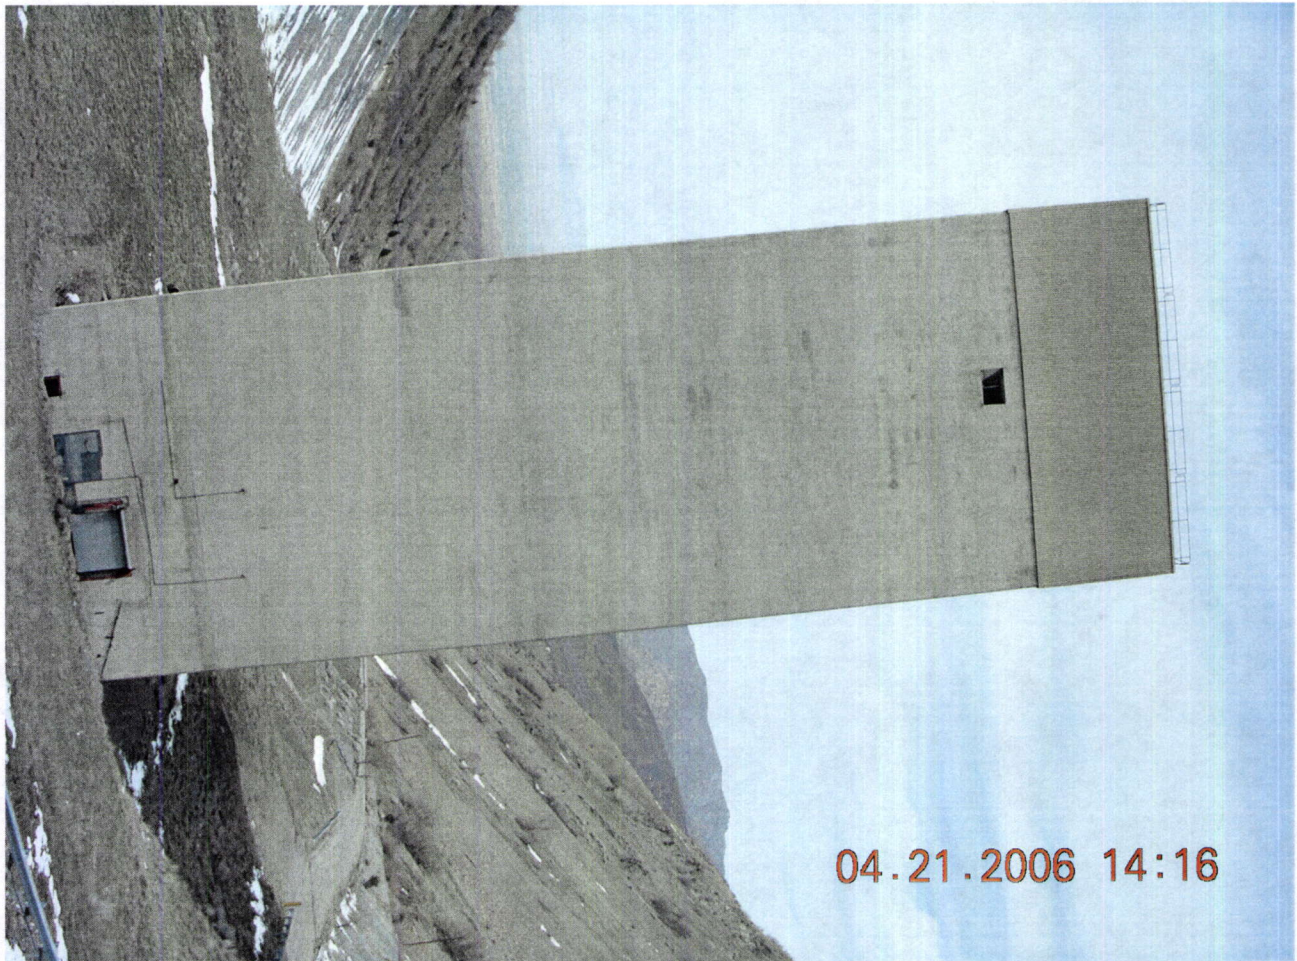
Carr Fork 005.jpg 2006/04/21 14:16:31

The main shaft and the Parvenu Portal are located ~1 mile above the locked gate. The Carr Fork production shaft has a concrete seal placed over the shaft opening and the concrete headframe has been locked to prevent unauthorized access.

CARR FORK HEADFRAME

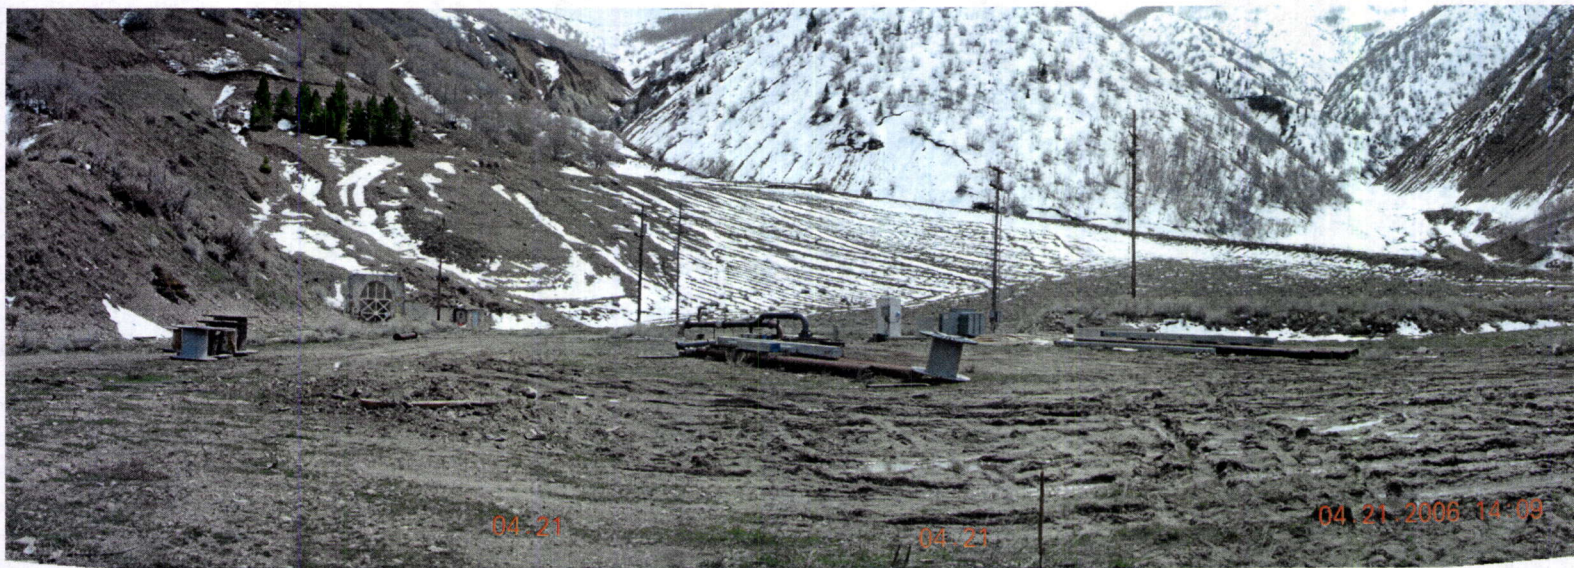
A ~2000 gpm pump has been placed in the Carr Fork service shaft, the pump is functioning as a part of the dewatering process for the Bingham Pit. Water pumped from this shaft is pumped through a pipeline that has been placed in the Parvenu Portal, which runs through the mountain and daylight near Bingham Canyon. This water is being used as process make up water at the Copperton

Concentrator. The service shaft has been sealed and the only evidence of the shaft is the riser pipe from the dewatering pump. Photos of the portal, service shaft area and headframe were taken and are enclosed in this report.

There are power lines running to the service shaft area to supply power for the pumping operation. These power lines were also used to supply power to several shallow wells. These wells have been decommissioned, but not closed to preserve the option of future use.

CARR FORK SERVICE SHAFT RISER PIPE + MCC
